STUDY ON THE RESTORATION OF THE HERMOUPOLIS QUARANTINE BUILDING

Michail Provelengios

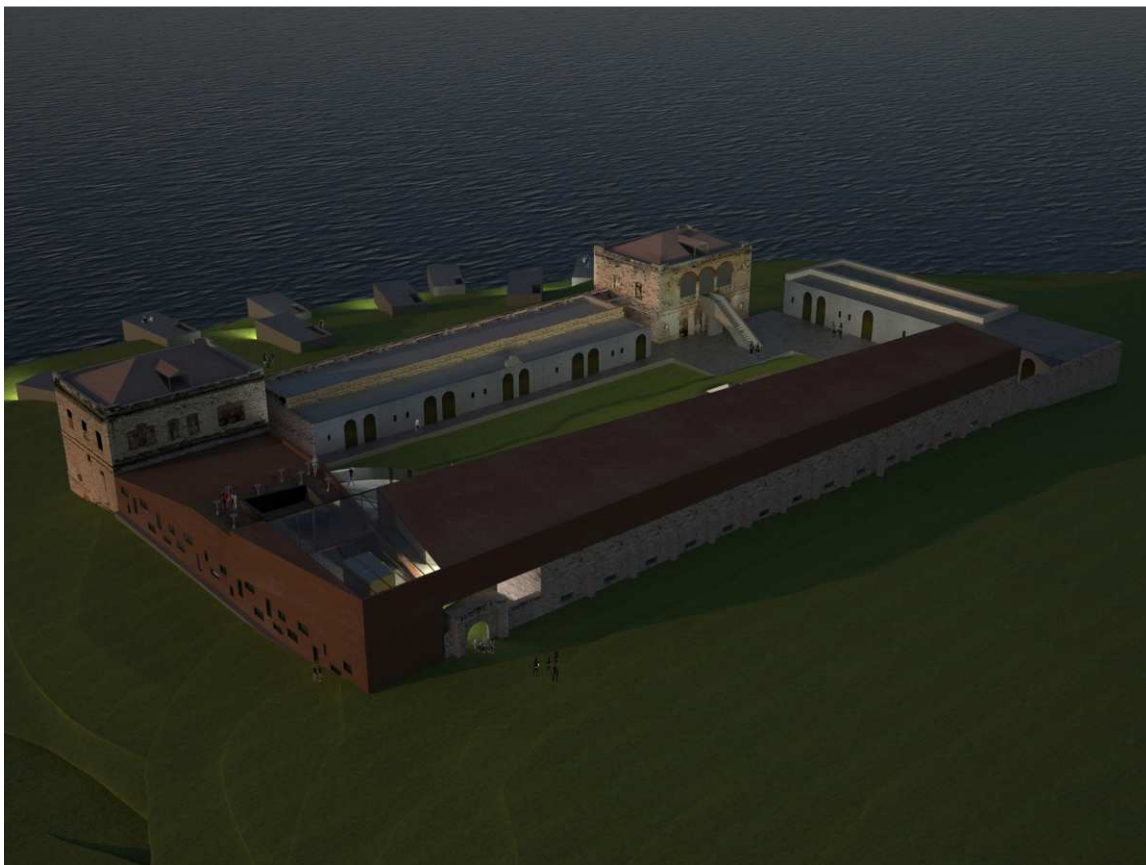
Pic. 9 Digital representation of the architectural proposal

The courtyard, after removal of the more recent modifications, walls and other auxiliary buildings, becomes again a shared space which incorporates the element of water. The south wing, already distorted by previous modifications, serves as a gallery of successive vaults offering shade to the bathers. In the former area of the administrative facilities, a new structure is created, that will house the reception and catering facilities, while the premises of the north-western tower will house the administrative facilities of the complex. The remaining ground-level buildings will function as bedrooms.

An extra addition in height will be made at the southern ground-level mass designed in such a way as to host the new bedroom wing, while the terrace on the western side will function as an open-air dining area.

Inside the courtyard, the outline of the missing semi-circular Weiler building is revived in an abstract fashion, providing access to the underground spaces of the Healing center. By opening

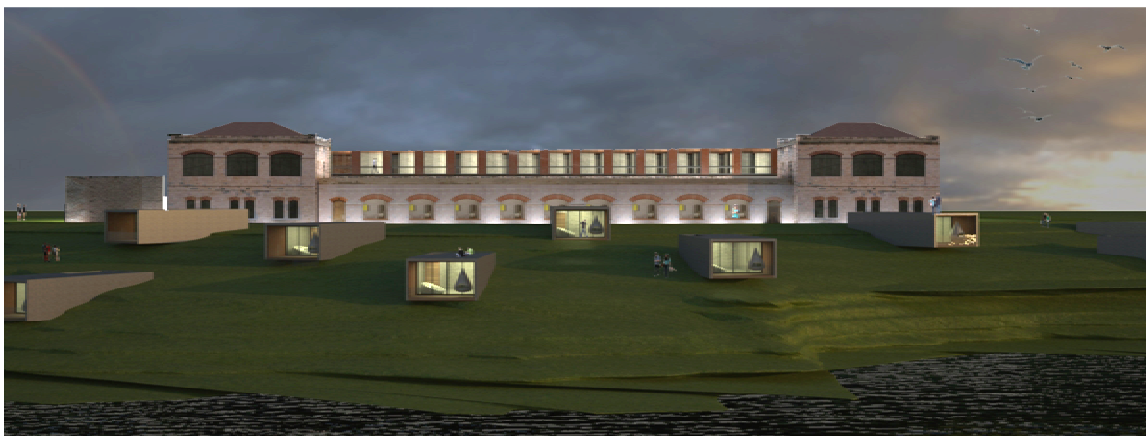
Pic. 10 Digital representation of the architectural proposal

Finally we should mention the addition of new apartments on the northern side of the complex with orientation towards the sea and the center of Hermoupolis in a way that will not affect the monumental facade of the complex.
